BUILDING SCIENCE SERIES 40

Engineering Aspects of the 1971 San Fernando Earthquake

This report presents the observations of the NBS on-site inspection team (most photographs in this report were taken by the team). The material presented herein is intended to serve as (1) a documentation of damage resulting from the earthquake and (2) as a source document for further studies, research, and recommendations. This is particularly important as necessary remedial work and restoration have resulted in the removal of evidence that is essential for studies and evaluations.

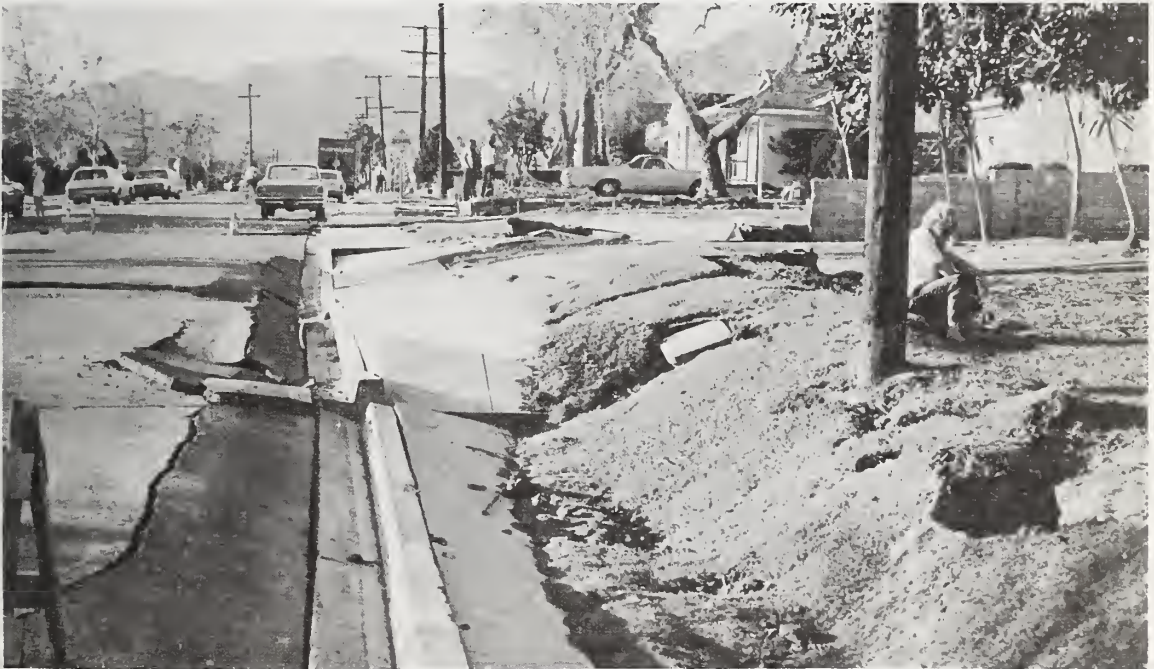
Figure 7.42 Damaged street and sidewalk along 8th Street, between Orange Grove Avenue and Fernmont Street, San Fernando.

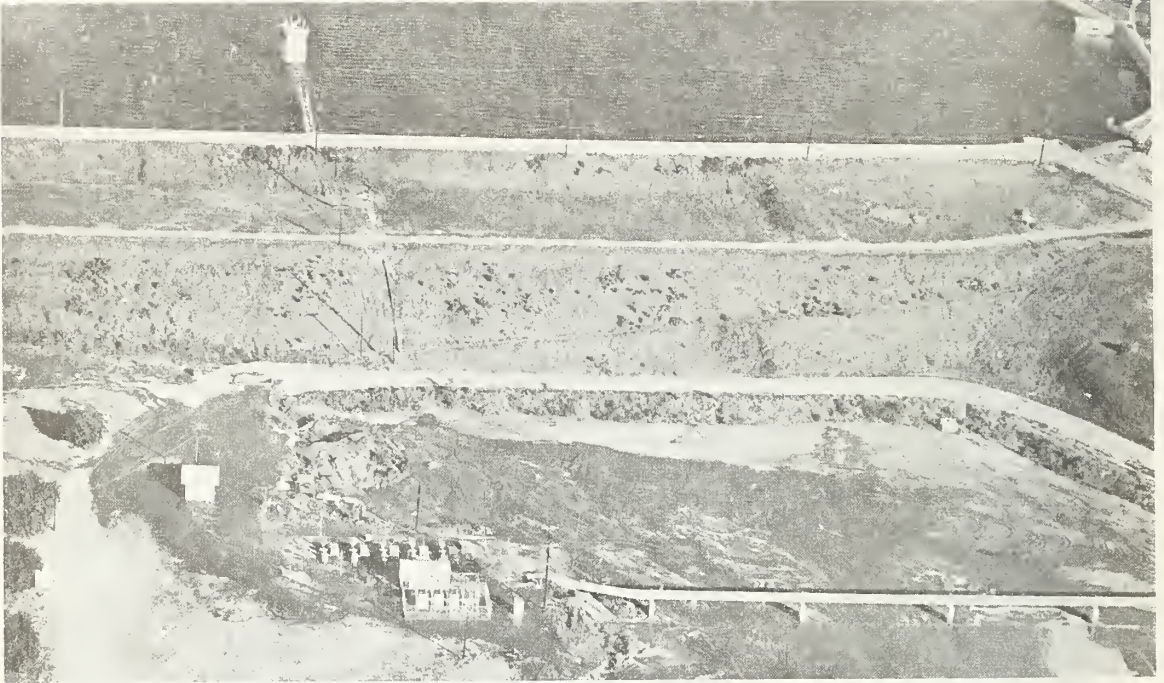
4. The Upper Van Norman Reservoir (location 9) with a capacity of 1800 acre-feet, was damaged. The Upper San Fernando dam, which was built in 1919-1921, is about 1200 ft in length along its axis and about 60 ft high. It settled about three feet and displaced laterally about five feet at the crest. However, the dam did not collapse and has been in use at about one-third capacity. Of the two intakes, the old one (Outlet No. 1) has cracked at the base; whereas, the new one (Outlet No. 2) did not sustain damage. Some water seepage appeared at the downstream side of the upper reservoir dam (fig. 8.3) as a result of damage in the drain system.

*Figure 8.3 Downstream face of the Upper San Fernando Dam.
Note the seepage at the foot of the dam.*

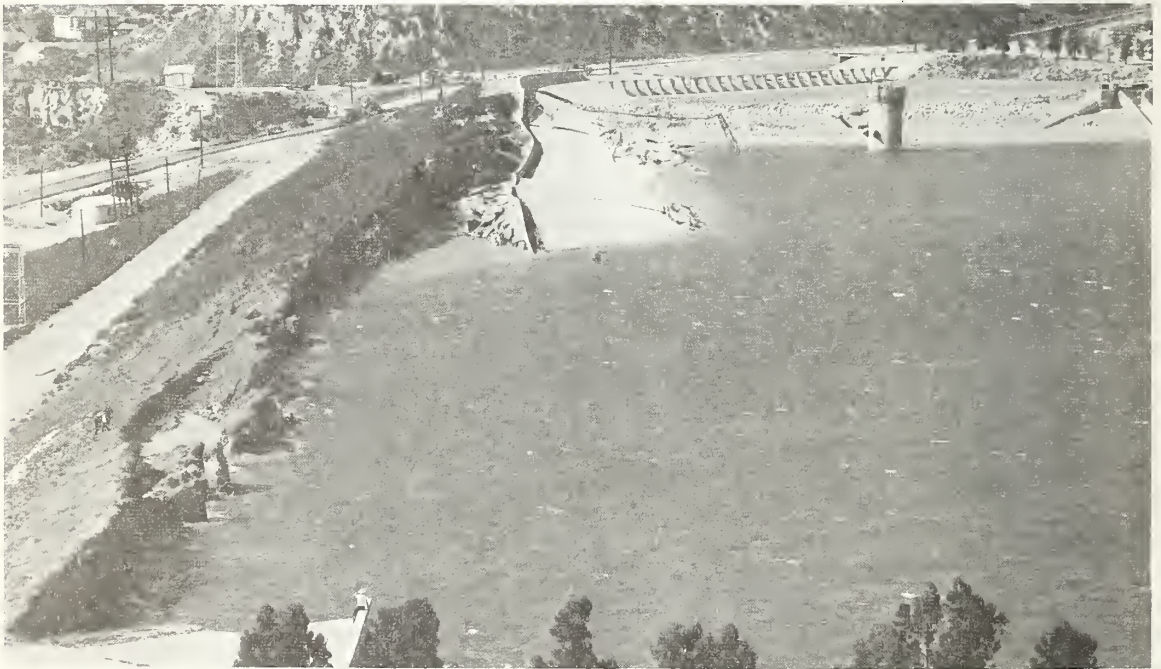
6. The Lower San Fernando Dam was severely damaged but did not collapse. It was built by the hydraulic fill method in 1913-1915 and raised and improved in 1930 and again in 1940. The reservoir can hold some 20,000 acre-feet of water at the water level of 1134 feet. At the time of the quake, the water level was 1110 feet, containing about 11,000 acre-feet. With this lower water level, although the crest of the dam collapsed during the quake (see fig. 8.4), the dam held back the water. With only a few feet of free-board to relieve the water pressure on the damaged dam, the water was immediately drained through the collapsed intake at a rate of 800 cubic feet per second (cfs) and discharged by 11 pumps at a rate of 190 cfs. The Lower Van Norman Reservoir is now out of service and is almost completely drained.

Figure 8.4 Collapsed crest of the Lower San Fernando Dam.

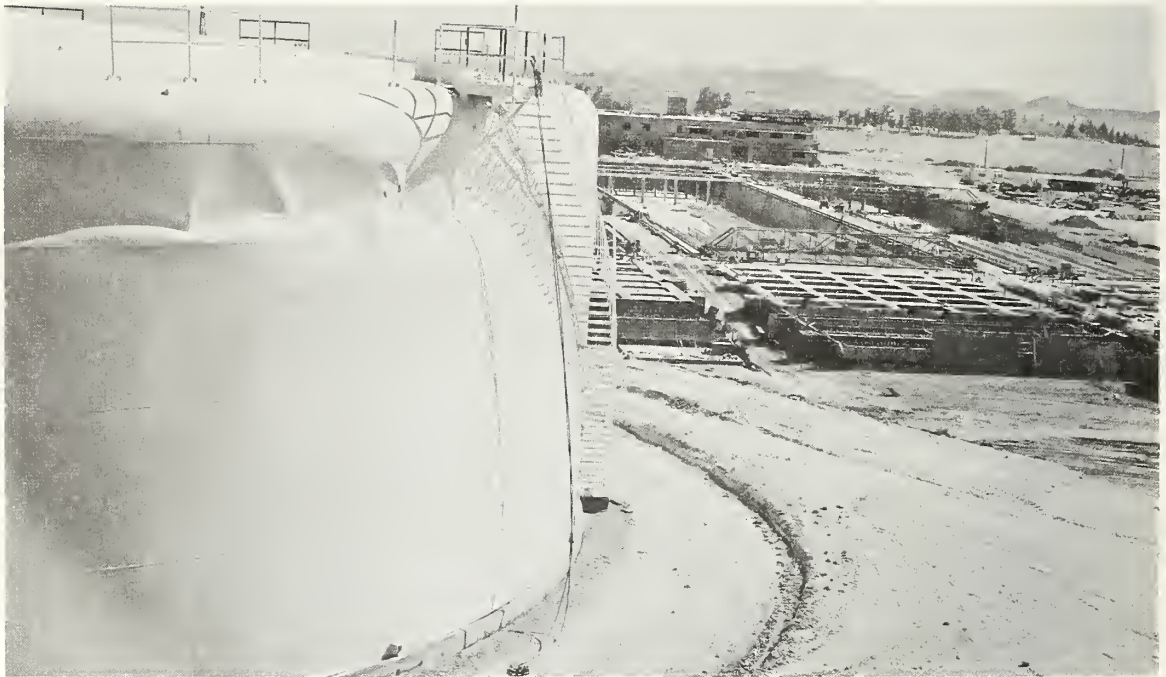
The intensity of ground movement at the Jensen Filtration Plant can be envisaged from the buckled 1.9-million-gallon water storage tank shown in figure 8.5. The tank, which was made of 3/8-in thick steel plate, was 30-ft high and 100-ft in diameter. This tank was located in the north-west area of the plant and was reported to be approximately one-half full at the time of the earthquake. Some of the anchor bolts, which held the tank to its foundation, were pulled out of their anchorage. The amount of pullout was, in general, greater on the north and south sides than the east and west sides. This indicates that some rocking motion of the tank occurred during the earthquake about an axis oriented in the east-west direction. The amount of uplift of the tank was greater on the south side than on the north side, as indicated by the amount of pull-out of the anchor bolts. The amount of pulled-out length was several inches on the

Figure 8.5 Buckled steel (3/8 in. thick) backwash tank at Joseph Jensen Filtration Plant.

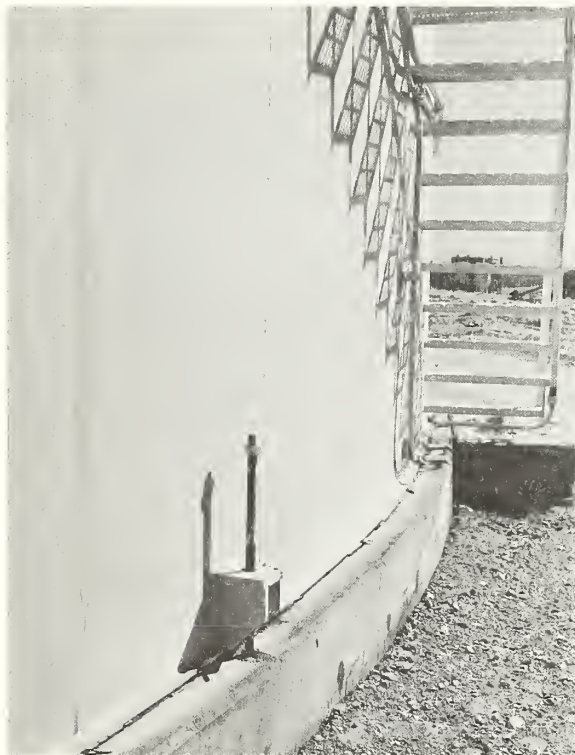
north side and as much as 19 inches on the south side (fig. 8.6). This difference in the amount of pull-out can possibly be explained by heavy machinery which was attached to the north side of the tank and apparently restrained the uplift.

Figure 8.6 Vertical Movement of tank pulled one-inch diameter anchor bolt out of concrete base.

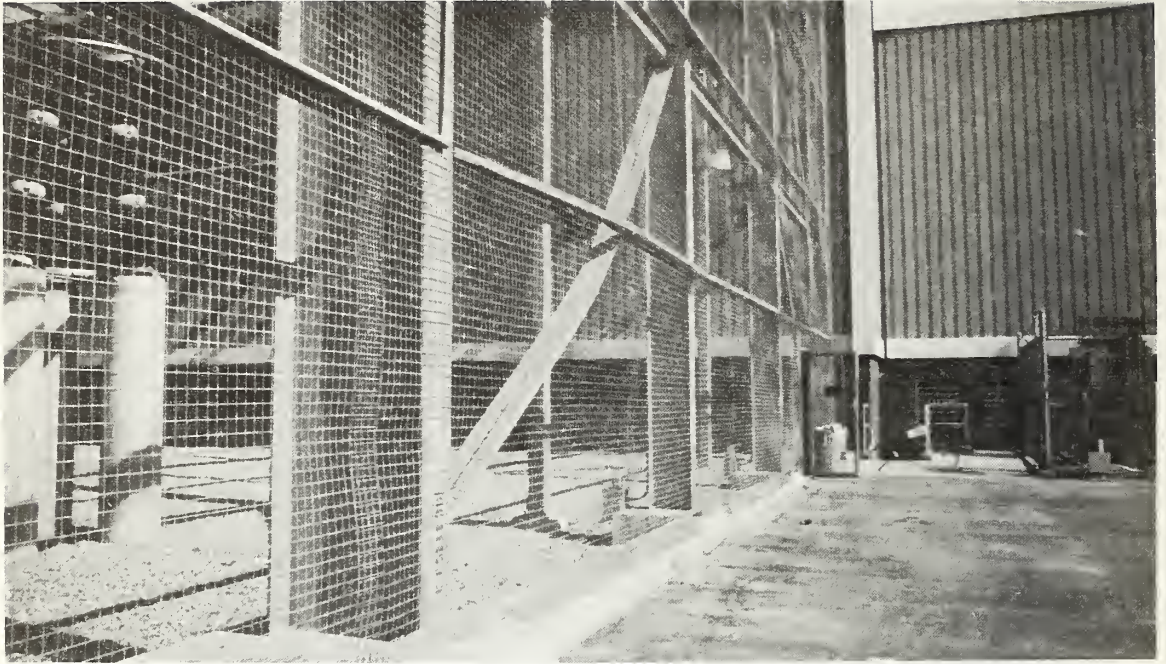
Figure 8.10 Buckled lateral bracing.

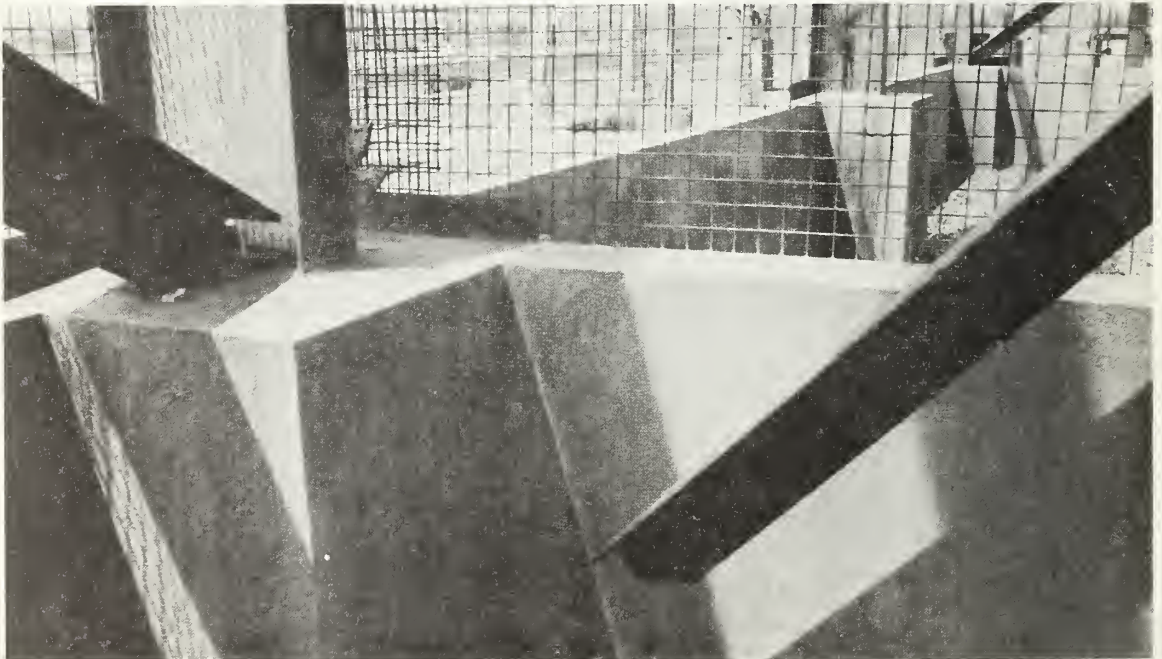
Figure 8.11 Fractured gusset plate.

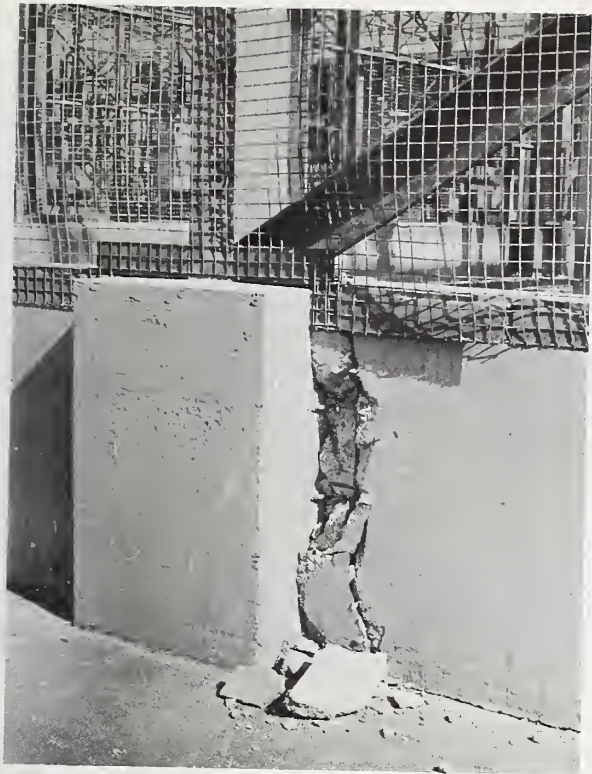
of these columns was damaged due to what appears to be independent movement that took place between the two sections of the building. The floor slab and the basement wall in this vicinity were also damaged. On the other hand, numerous damages were sustained by the bare steel frame structures over the transformer yards. Many braces were buckled, stretched, and broken at gusset plates (fig. 8.10 and 8.11). Some columns were bent and, in several places, cracks occurred between the column pedestal and the concrete wall which surrounded the yard (fig. 8.12).

Figure 8.12 Concrete spalling at one of the joints between a column pedestal and an enclosure wall surrounding the electrical transformer yard.

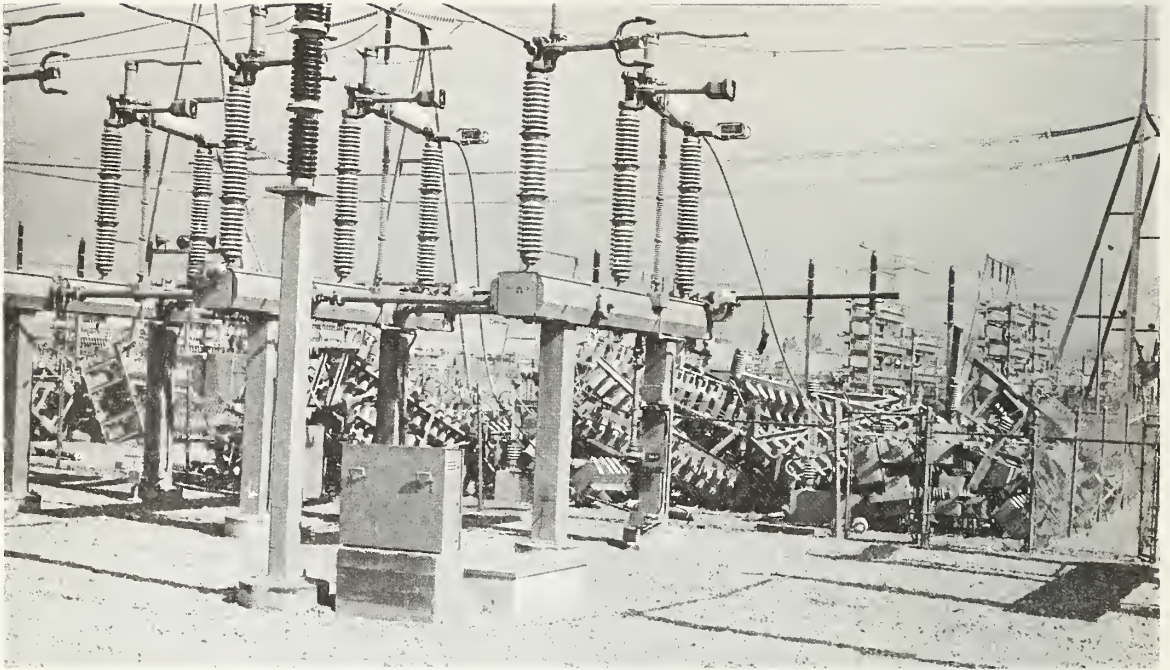
Much outdoor electrical equipment was supported on insulators, (fig. 8.13). Equipment collapsed due to failure of these insulators during the earthquake as shown in figure 8.14.

Figure 8.14 Destroyed electrical capacitor banks (in background) at Sylmar Converter Station.

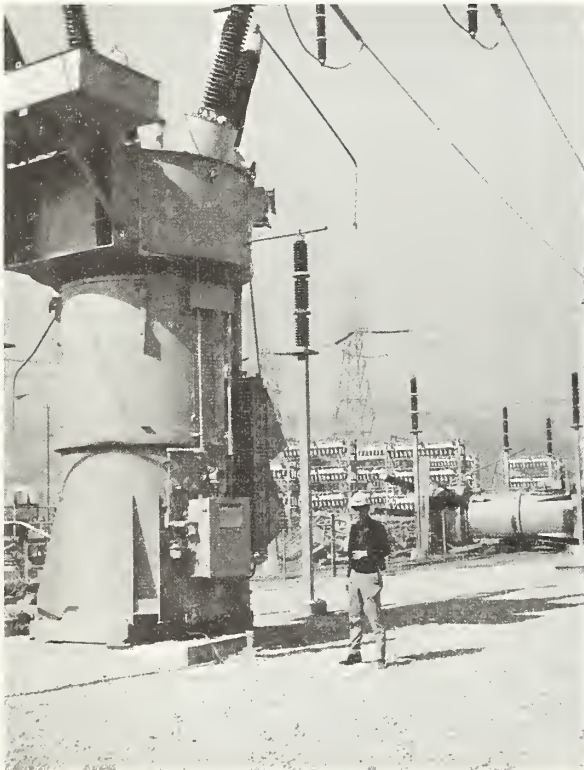
Several large oscillators were toppled and dislodged due to failure of their anchorage to the foundation pad (fig. 8.15). Each oscillator was attached to four 12-in by 12-in by 3/4-in anchor plates. Each of these plates was anchored to the concrete pad with four 1/2-in studs. A close examination showed that all studs were fractured at the base metal. Some fractured studs showed only partial fusion to the base anchor plate. The base steel plates and a concrete pad to which the plates were embedded are shown in figures 8.16 and 8.17, respectively. In figure 8.17 the broken studs are indicated by arrows.

Figure 8.15 Toppled and dislodged oscillators. (J. H. Rainer photo)

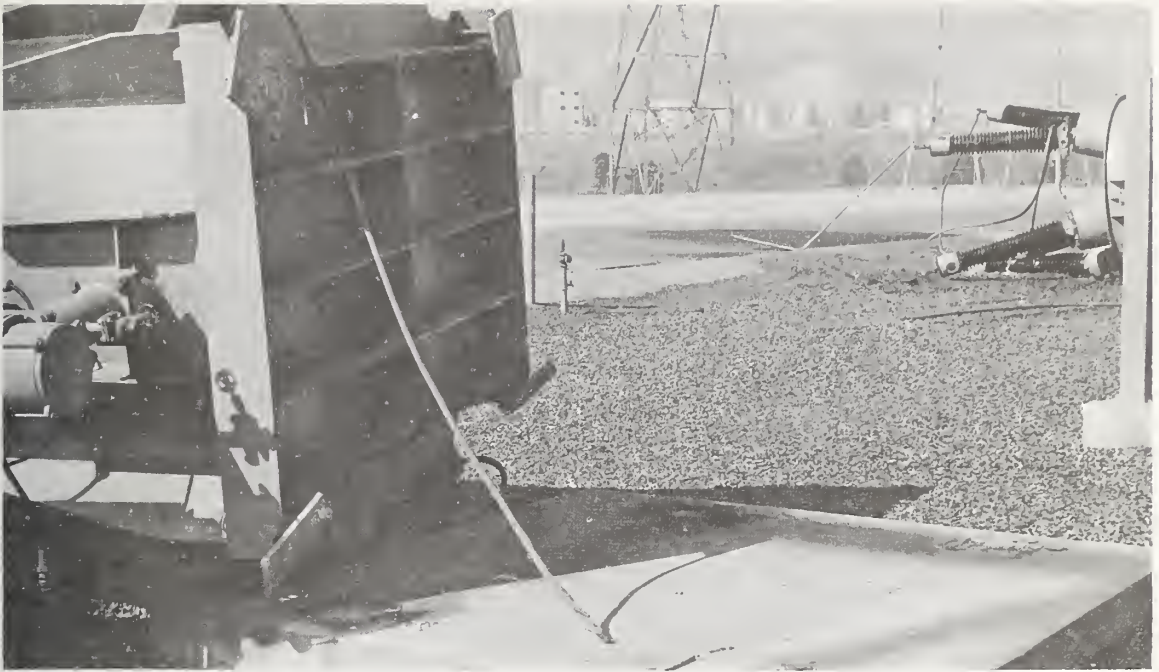
Figure 8.16 View showing bottom of toppled oscillator with its steel base plates and top of the foundation slab.

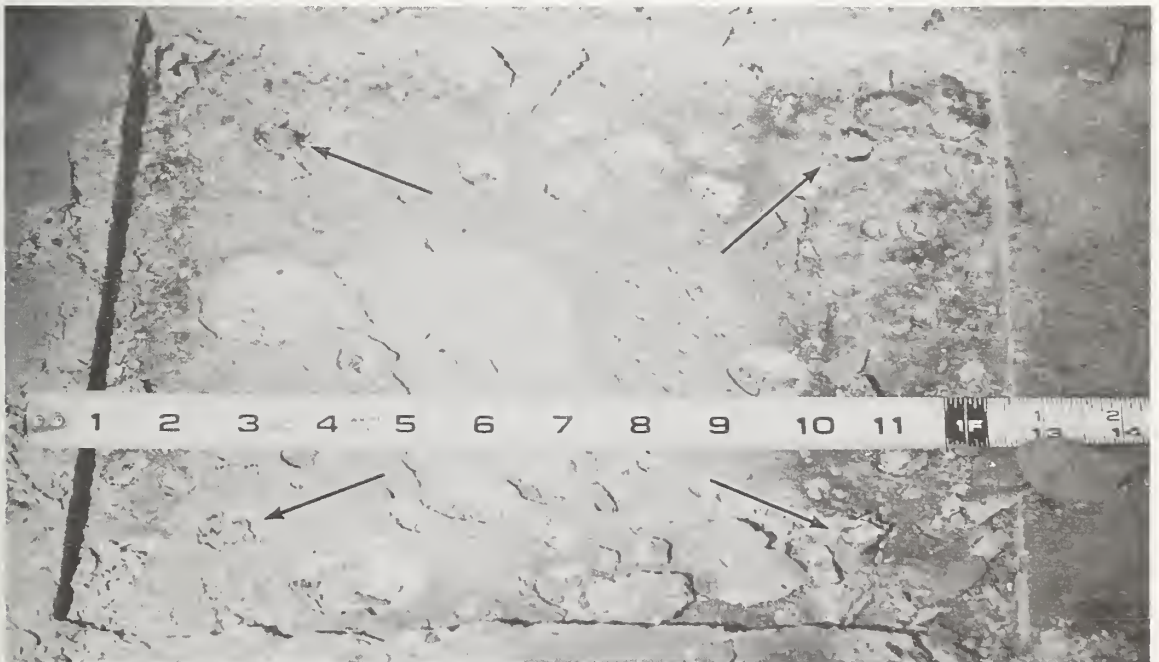
Figure 8.17 Concrete pad showing the broken studs embedded in it. Porosity in the weld of the upper-right corner stud can be seen in this photograph.

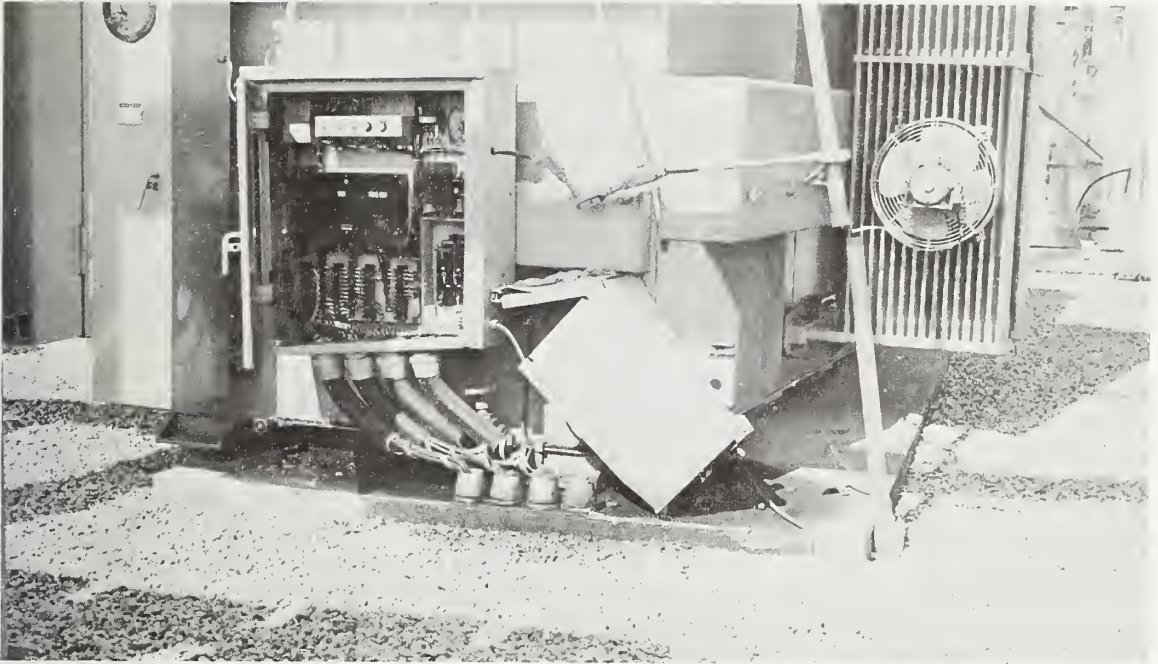
Numerous large transformers in the radio-shielded yards were moved laterally on their foundation slabs as anchor bolts were sheared off due to lateral forces. A typical example of such a failure is shown in figure 8.18.

Figure 8.18 Electrical transformer which moved laterally on its foundation slab.

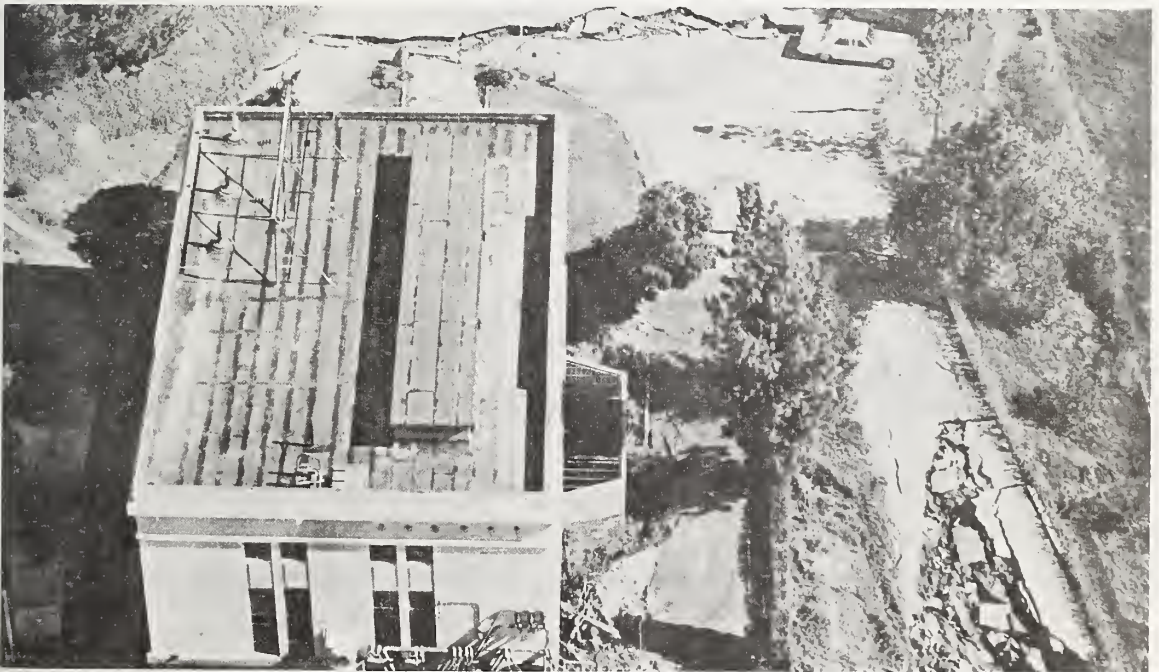
The power plant which is located just north of the Upper Van Norman Reservoir was dropped about three feet, thereby shearing off the end of the penstock and breaking the bypass gate. This station had a generating capacity of 6000 kilowatts and is out of service indefinitely. Severe ground failure around the plant is shown in figure 8.19.

Figure 8.19 Aerial view of the San Fernando Power Plant.

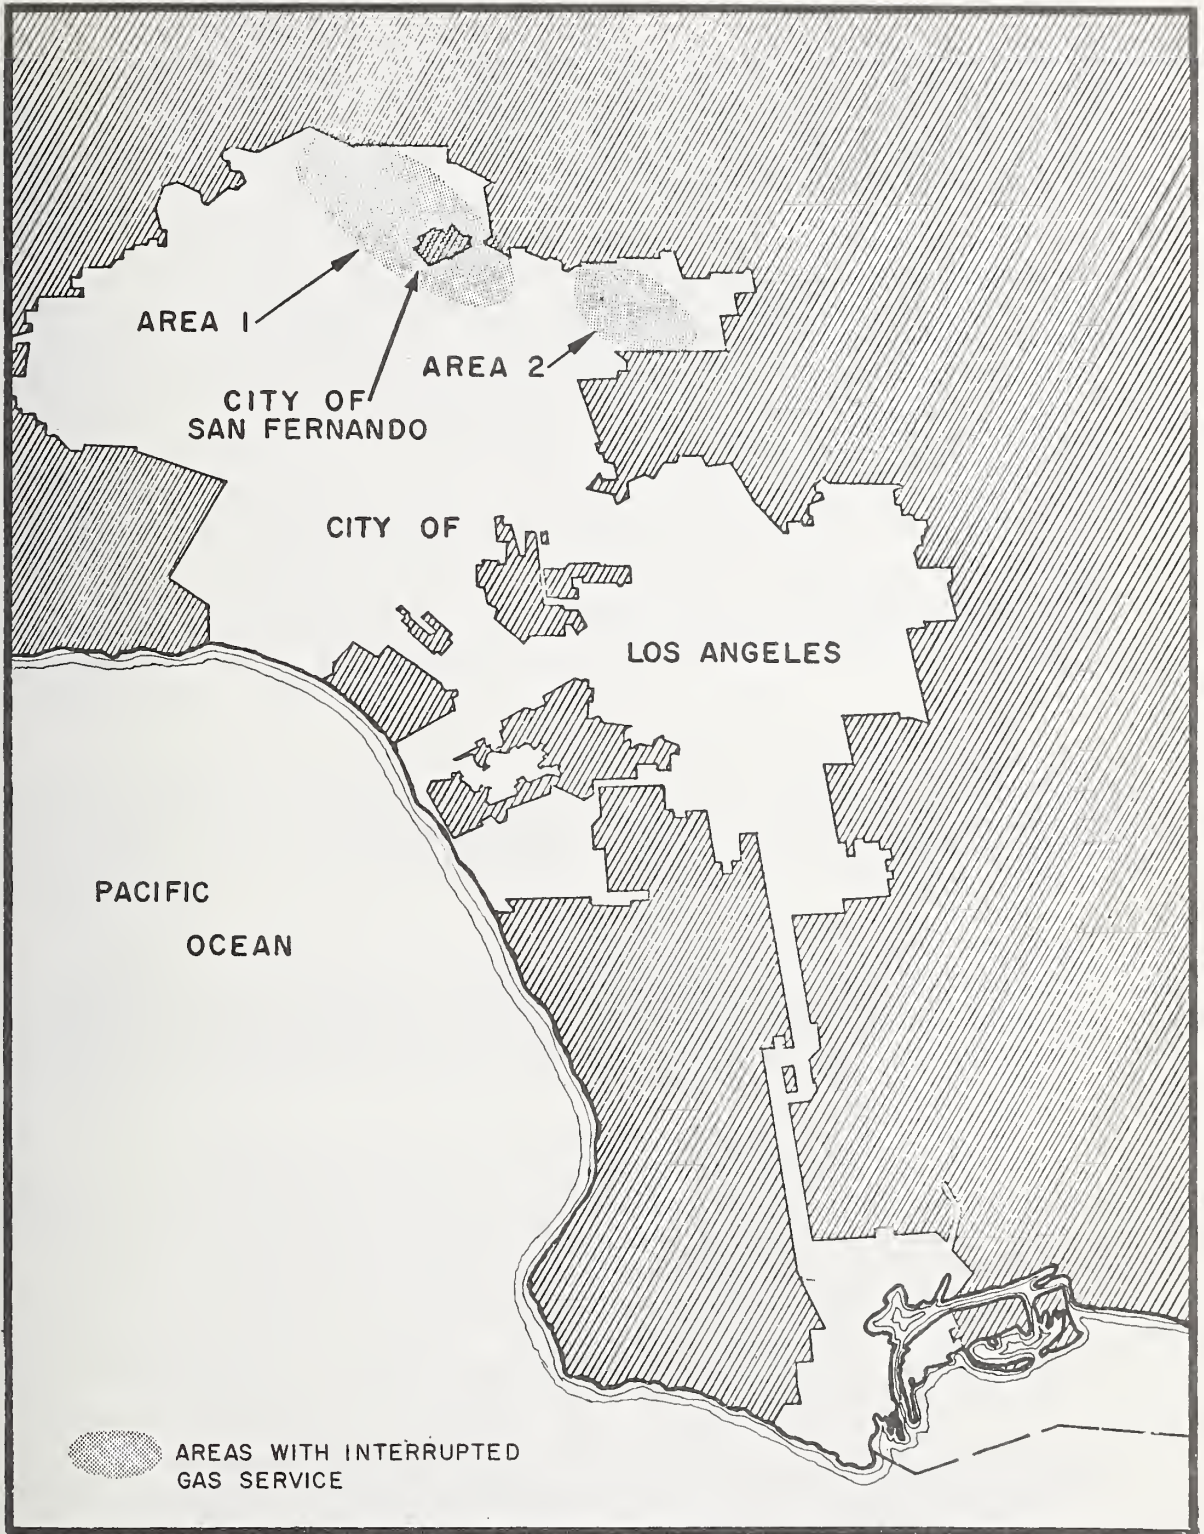
Figure 8.20 Areas with interrupted gas service.

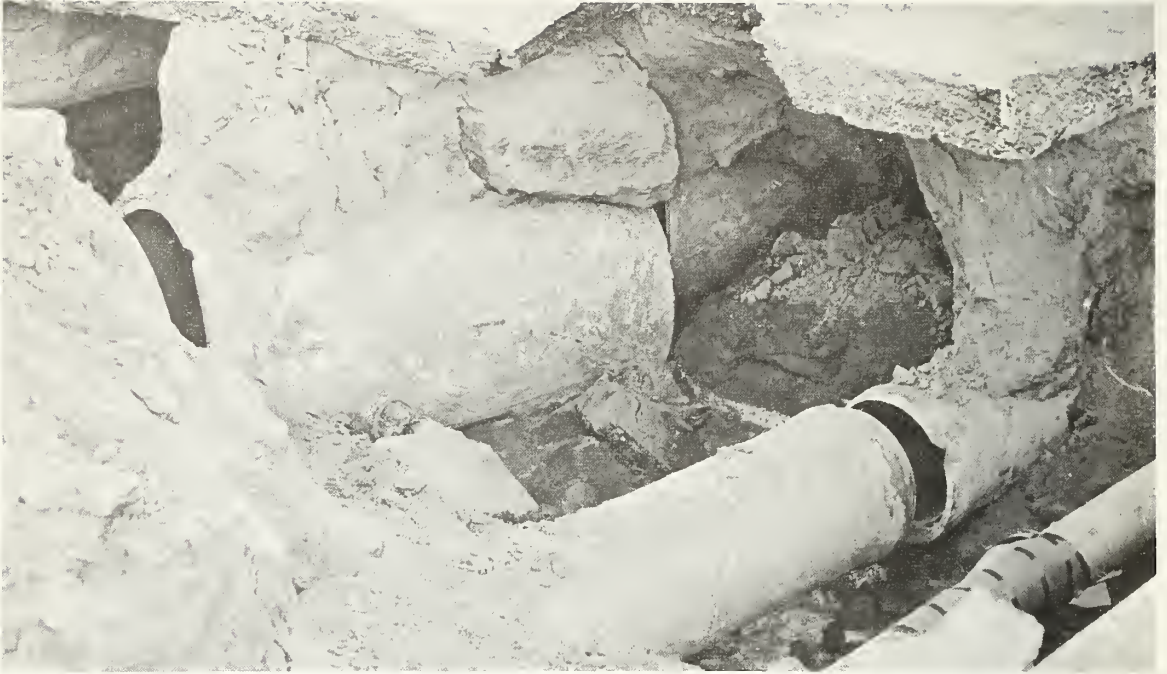
Many broken gas lines were flooded with water from broken water mains. The greatest damage of this type occurred in the northern corner of the City of San Fernando where, as shown in figure 8.21, ruptured gas, water, and sewer lines were buried adjacent to each other. Some 10 days after the quake, a problem of a similar nature occurred in the Sunland-Tujunga area, some 6 miles east of the City of San Fernando, where earthquake-loosened soil worked its way into the broken gas lines and filters in a regulator station. This disrupted gas service to about 10,000 customers for a period of up to one day, in the area bounded by Sherman Grove Avenue, Haynes Canyon Avenue, the San Gabriel Mountains and Verdugo Mountains (fig. 8.20, Area 2).

Figure 8.21 Close-up view of ruptured sewer, water, and gas lines.

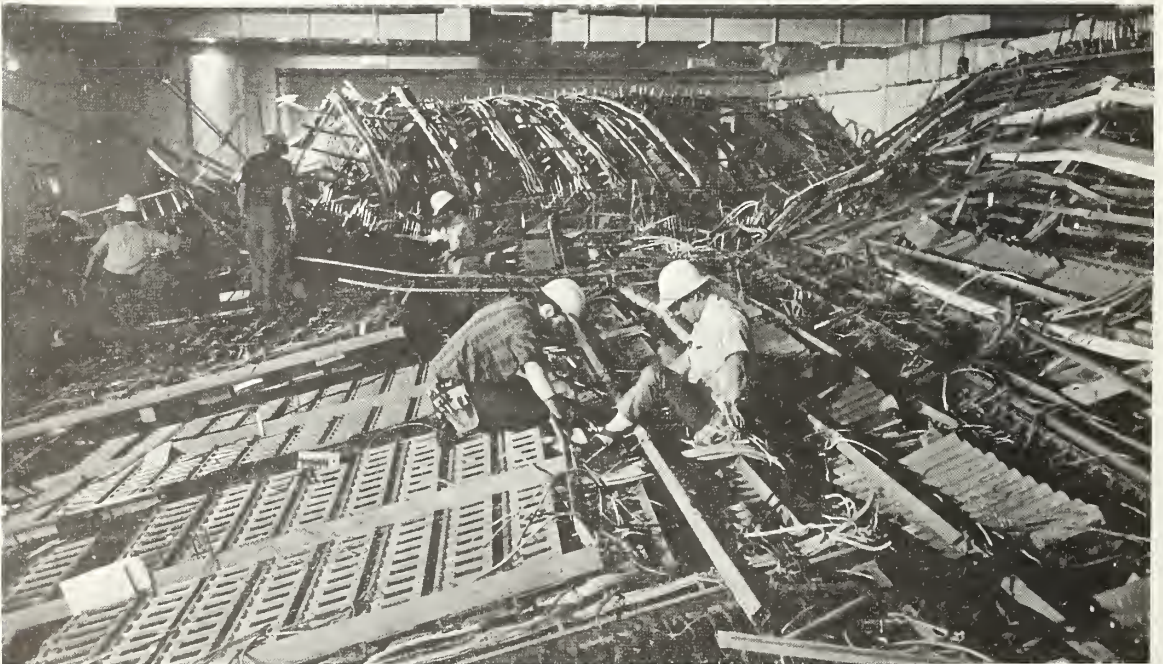
The equipment damage was concentrated at the Sylmar Central Office where all the switching equipment was rolled over (fig. 8.22). Loss of this central office left 9,500 Sylmar customers without telephone service.

Figure 8.22 Toppled and damaged telephone switching equipment at Sylmar Central Office of General Telephone Company.

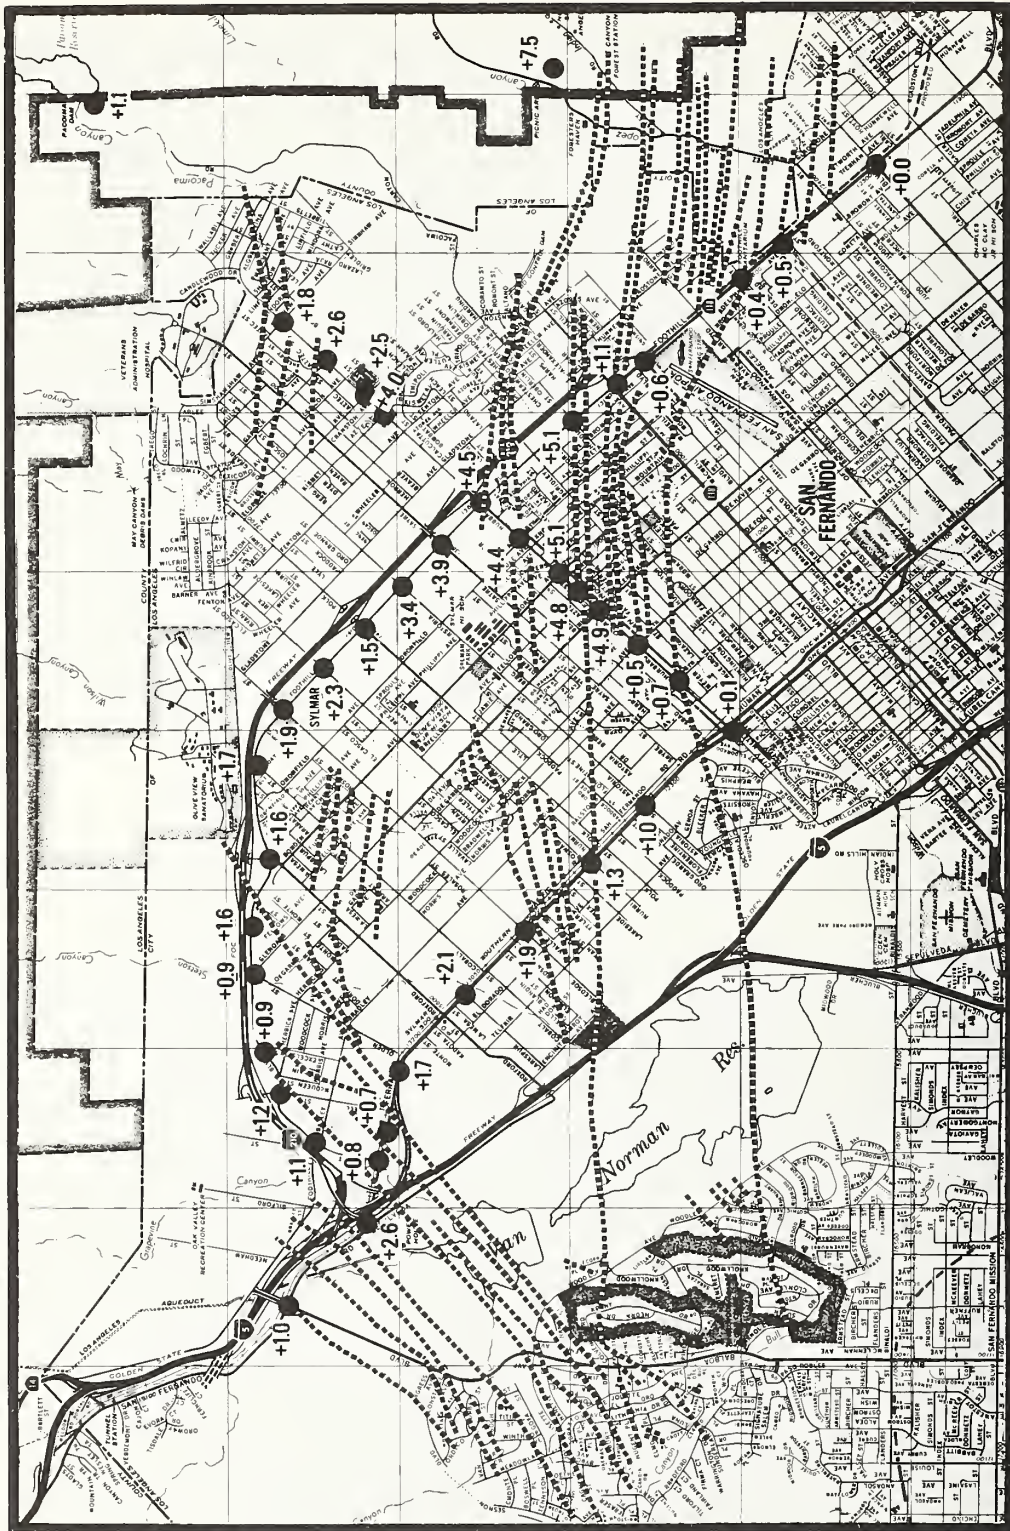
The Department of Public Works of the City of Los Angeles has conducted a survey to determine the changes in elevation caused by the earthquake. Their results are presented in figure 8.23. The numbers indicate changes of evaluation, assuming that the reference point--the intersection of Van Nuys and Foothill Boulevards--has remained at the original elevation. The maximum change of 7.5 ft was measured in Lopez Canyon, with a rise of about 5 ft near the northern part of the City of San Fernando (intersection of Harding Street and Foothill Boulevard). Figure 8.23 also

Figure 8.23 Changes in elevation (in feet) caused by earthquake. Dashed lines indicate estimated location of ground surface breaks.

shows the observed and estimated location of many surface breaks and faults in the area. Much damage to sewers and storm drains occurred in these areas which experienced considerable ground movement.

In the City of San Fernando complete rebuilding of the sewer system will be needed in the area bounded by Hubbard Street, Glenoaks Boulevard, Harding Street, and Eighth Street (see fig. 8.23 for location).

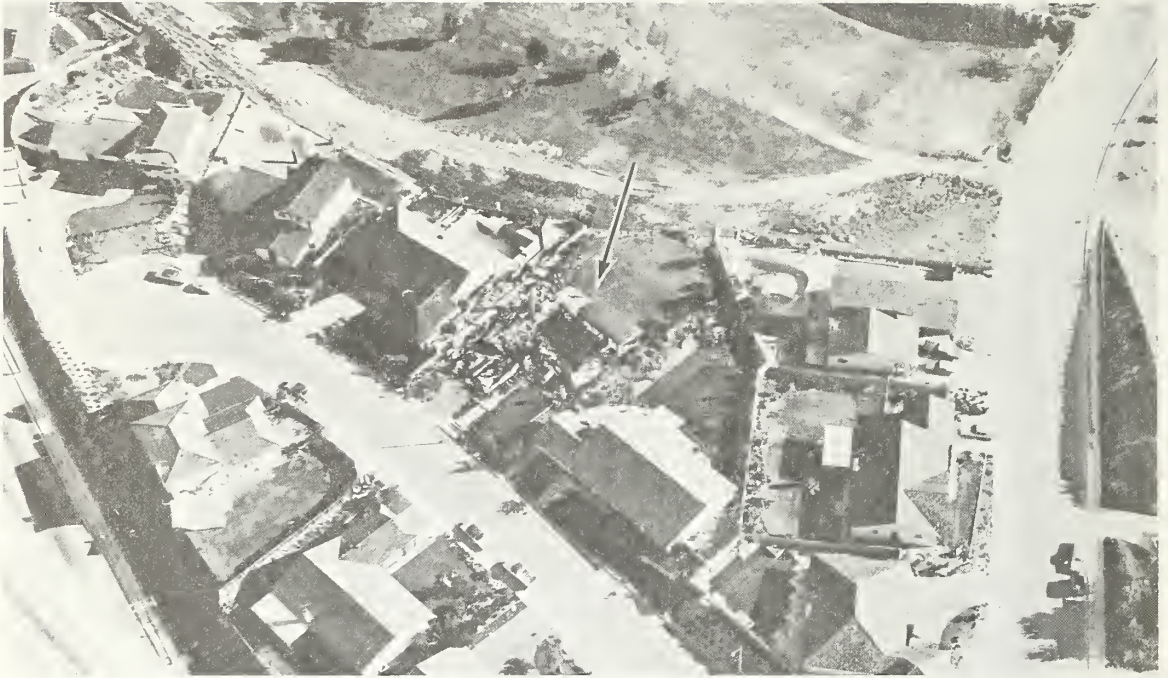
Figure 8.24 House in Knollwood area destroyed by fire.

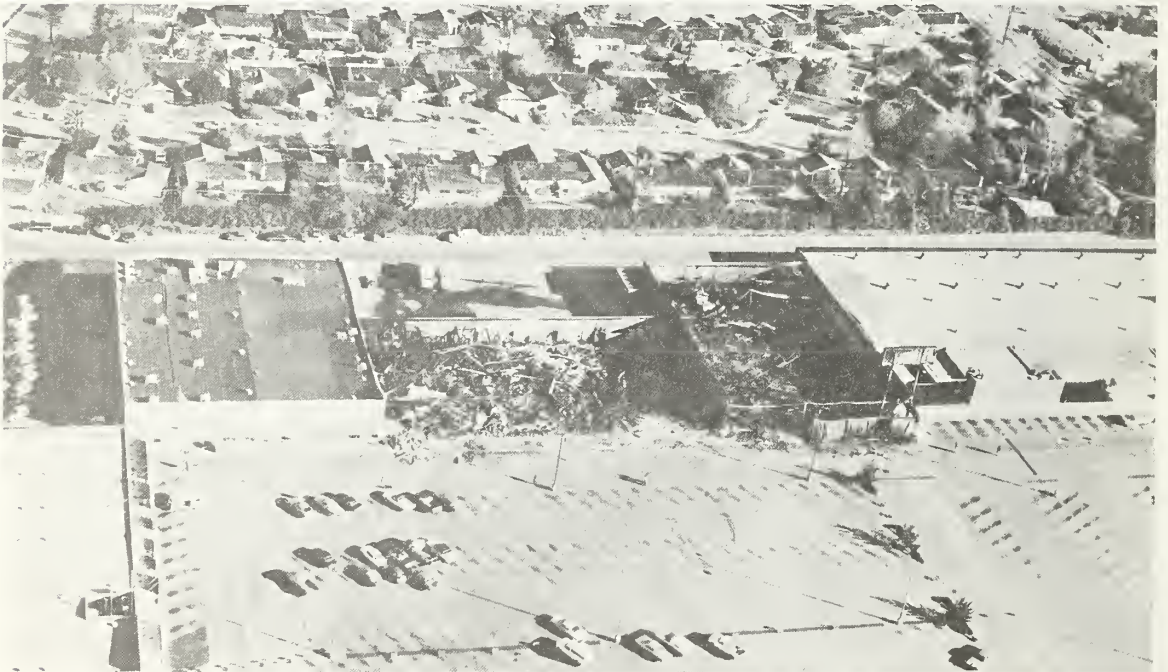
Figure 8.25 Commercial buildings destroyed by fire (Chatsworth Street and Zelzah Avenue, Granda Hills).

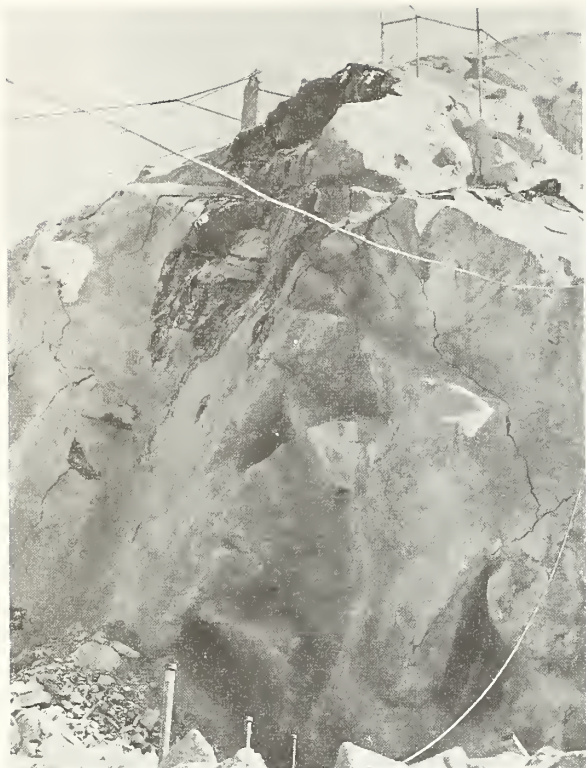
Dams - Pacoima Dam, built in 1928 as a 370 ft high concrete-arch structure, is the only major District dam in the Sylmar area (see fig. 8.26). Significant damage occurred to the gunite abutments (figs. 8.27 and 8.28), and massive rockslides occurred in the vicinity of the dam (fig. 8.29) [8.4]. Although damaged evaluation is not complete, preliminary reports indicate there was no structural damage to this dam. Water level behind the dam was low at the time of the earthquake.

Figure 8.27 Damage to gunite left abutment, Pacoima Dam.

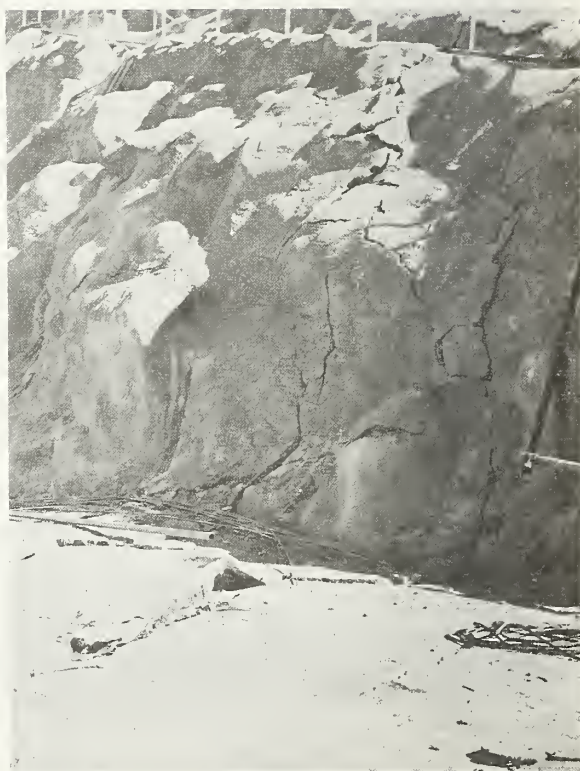
Figure 8.28 Cracks in gunite, left abutment downstream of Pacoima Dam.

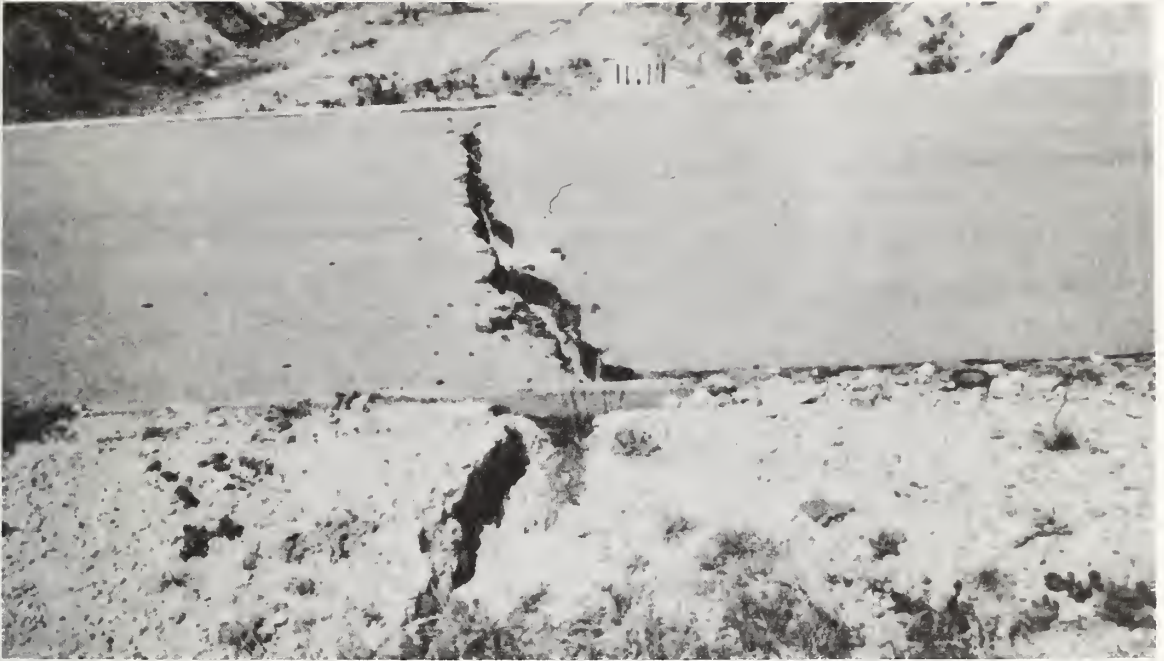
Debris Basin, there were cracks in the dam fill on both sides of the spillway (fig. 8.30) and in the facing slab parallel to the spillway invert (fig. 8.31). Hog Debris Basin and Sombrero Debris Basin also suffered similar damage.

Figure 8.30 Looking northwesterly toward basin showing crack in the pavement and a 2-inch vertical displacement of paved crest of dam (Stetson Debris Basin).

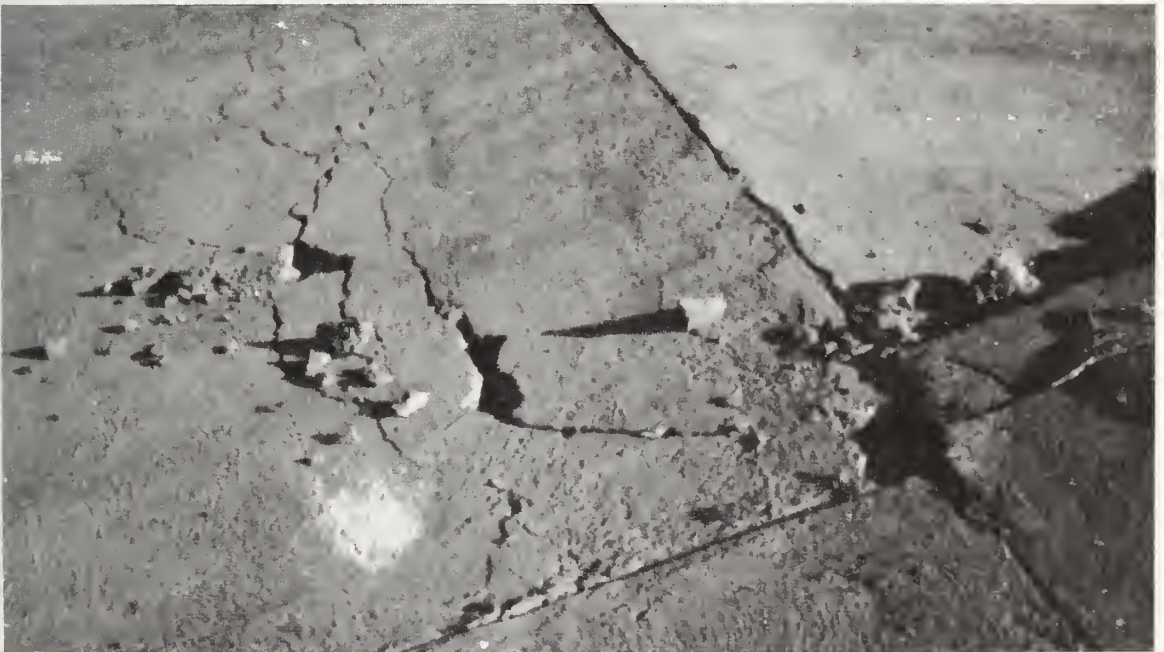
Figure 8.31 Looking easterly showing damage to facing slab; Stetson Debris Basin.

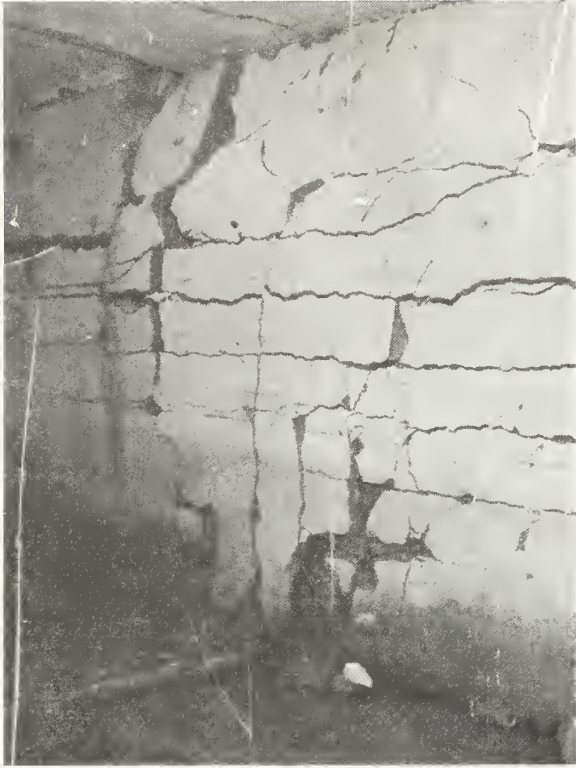
Channels - The Wilson Canyon Channel has a reinforced concrete box which was badly damaged (figs. 8.32 and 8.33). Concrete walls along the Lopez Canyon Channel were also badly damaged (figs. 8.34 and 8.35). Other channels which were damaged are the Mansfield Channel and the Pacoima Wash Channel.

Figure 8.32 *Left wall buckled inward at station 45+10. Wilson Canyon Channel.*

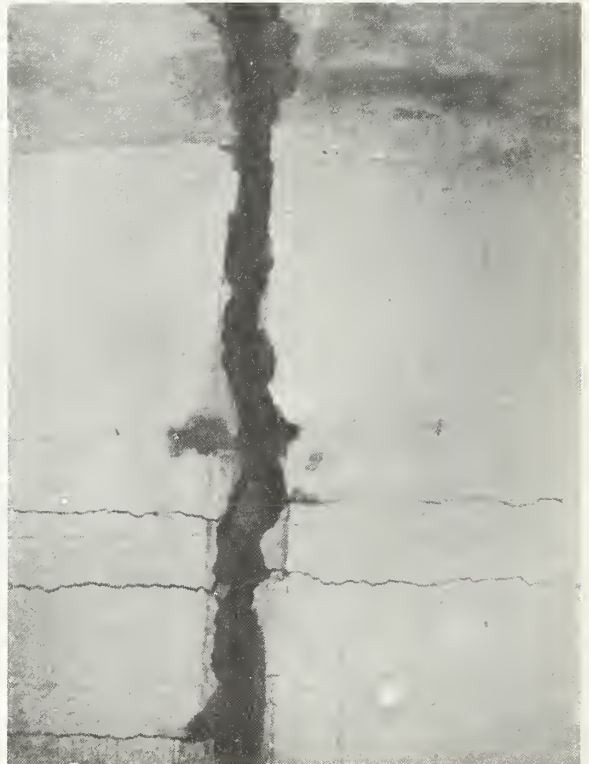
Figure 8.33 *Reinforced concrete box has completely separated (4 to 12 inches) at several locations between stations 44+00 and 49+93; Wilson Canyon Channel.*
